Impact Testing of the Orbiter Thermal Protection System

Justin Kerr, Johnson Space Center

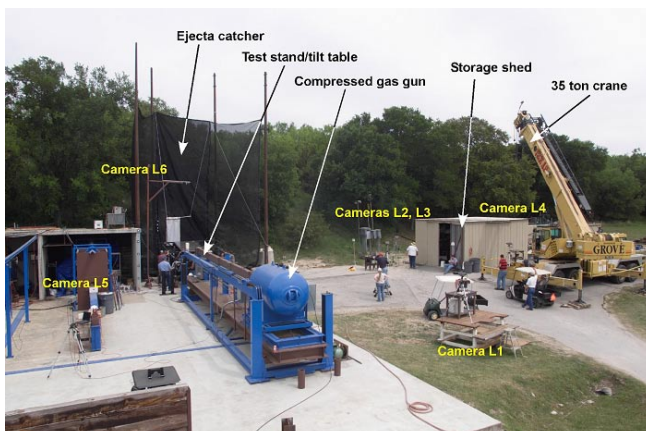
To prepare for the leading edge test program, five tests were conducted on LI-900 TPS tiles bonded to a left MLGD. These tests were used to evaluate the response of tile impacted by foam at representative velocities and angles and to verify test facility, instrumentation, and high-speed camera readiness. BX 250 foam at sizes (14,000, 20,000, 30,000 cm³), velocities (200 to 235 m/sec), and impact angles (5 to 13 deg) representative of the

debris were shot at the MLGD with a large compressed-air gun facility at SwRI. The results demonstrated very little damage to the tiles for the range of parameters tested. None of the damage could be considered critical.

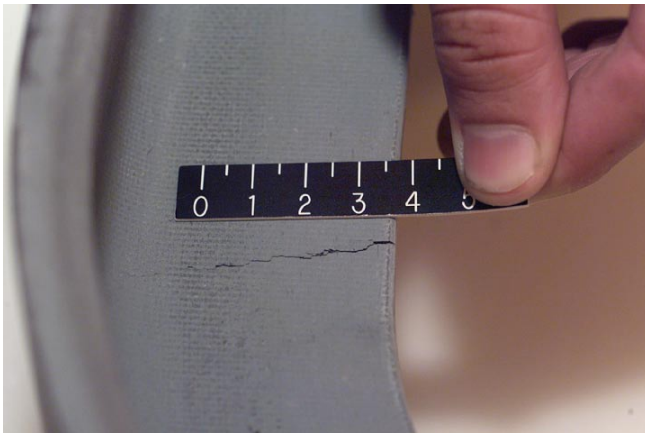
For the panel 6L test, a 20,000-cm³ BX 250 foam projectile impacted the panel at a velocity of 234 m/sec. A lower corner of the foam block first impacted the panel near the slip-side rib. The resulting crack, which measured approximately 14 cm, traversed the entire rib and lock and 1.9 cm onto the lower panel face. In addition, the panel 6L T-seal exhibited a crack 6.4 cm along its web.

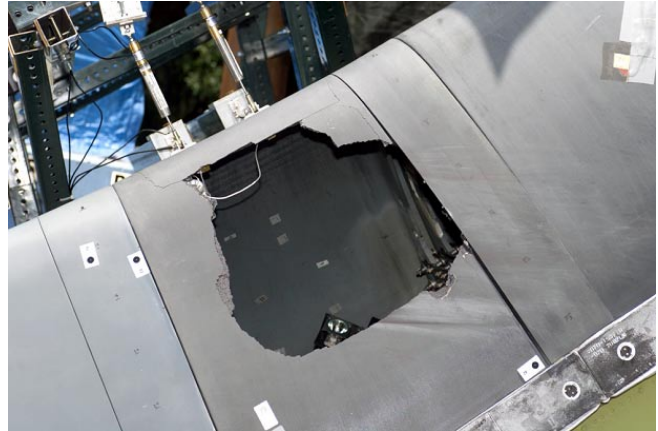
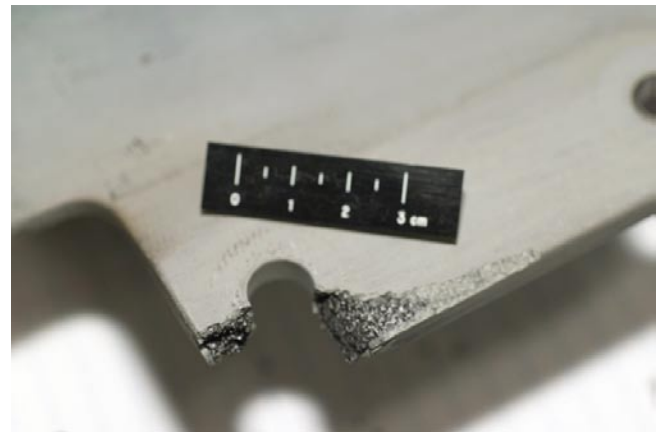
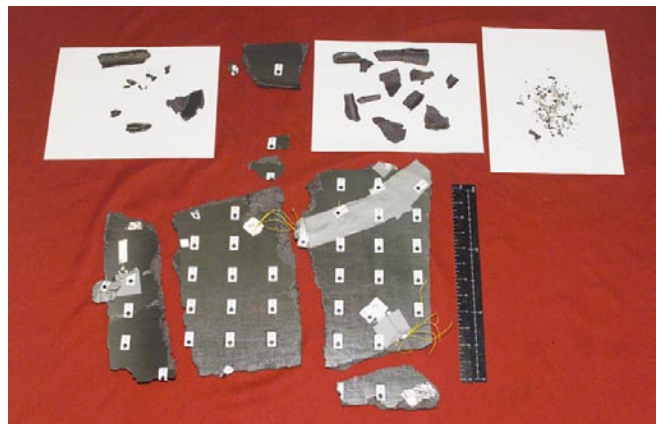
The test conducted on panel 8L yielded results that were consistent with estimated damage inferred from onboard sensor data and forensic evidence. A foam block of the same mass and approximately the same size as that tested for panel 6L was launched to a velocity of 237 m/sec. The foam block

initially impacted the panel several centimeters closer to the middle of the panel and was clocked at an angle such that most of the leading edge of the block loaded the panel. The foam block produced a hole 41 cm by 42.5 cm at the widest point. Investigators noted cracks along the lock and slip sides of the panel. The panel 8L T-seal was cracked at its lug, which opened a slight gap between the panel and the seal. Investigators found the RCC materials displaced from the panel inside the test article. The largest two fragments were approximately 20 cm by 33 cm and 19 cm by 29 cm. Joint scenario testing of TPS materials ended upon completion of this test.
